REPLACING AN URBAN FOUNDATION

GEORGE B. MORSCHAUSER JAMES E.B. DAVIS

An extension of Baltimore's Metro subway will pass through the Inner Harbor area, where dewatering could hasten deterioration of timber piles that support several old buildings. To stabilize one of these, the specialty contractor replaced the original foundation with pin piles.

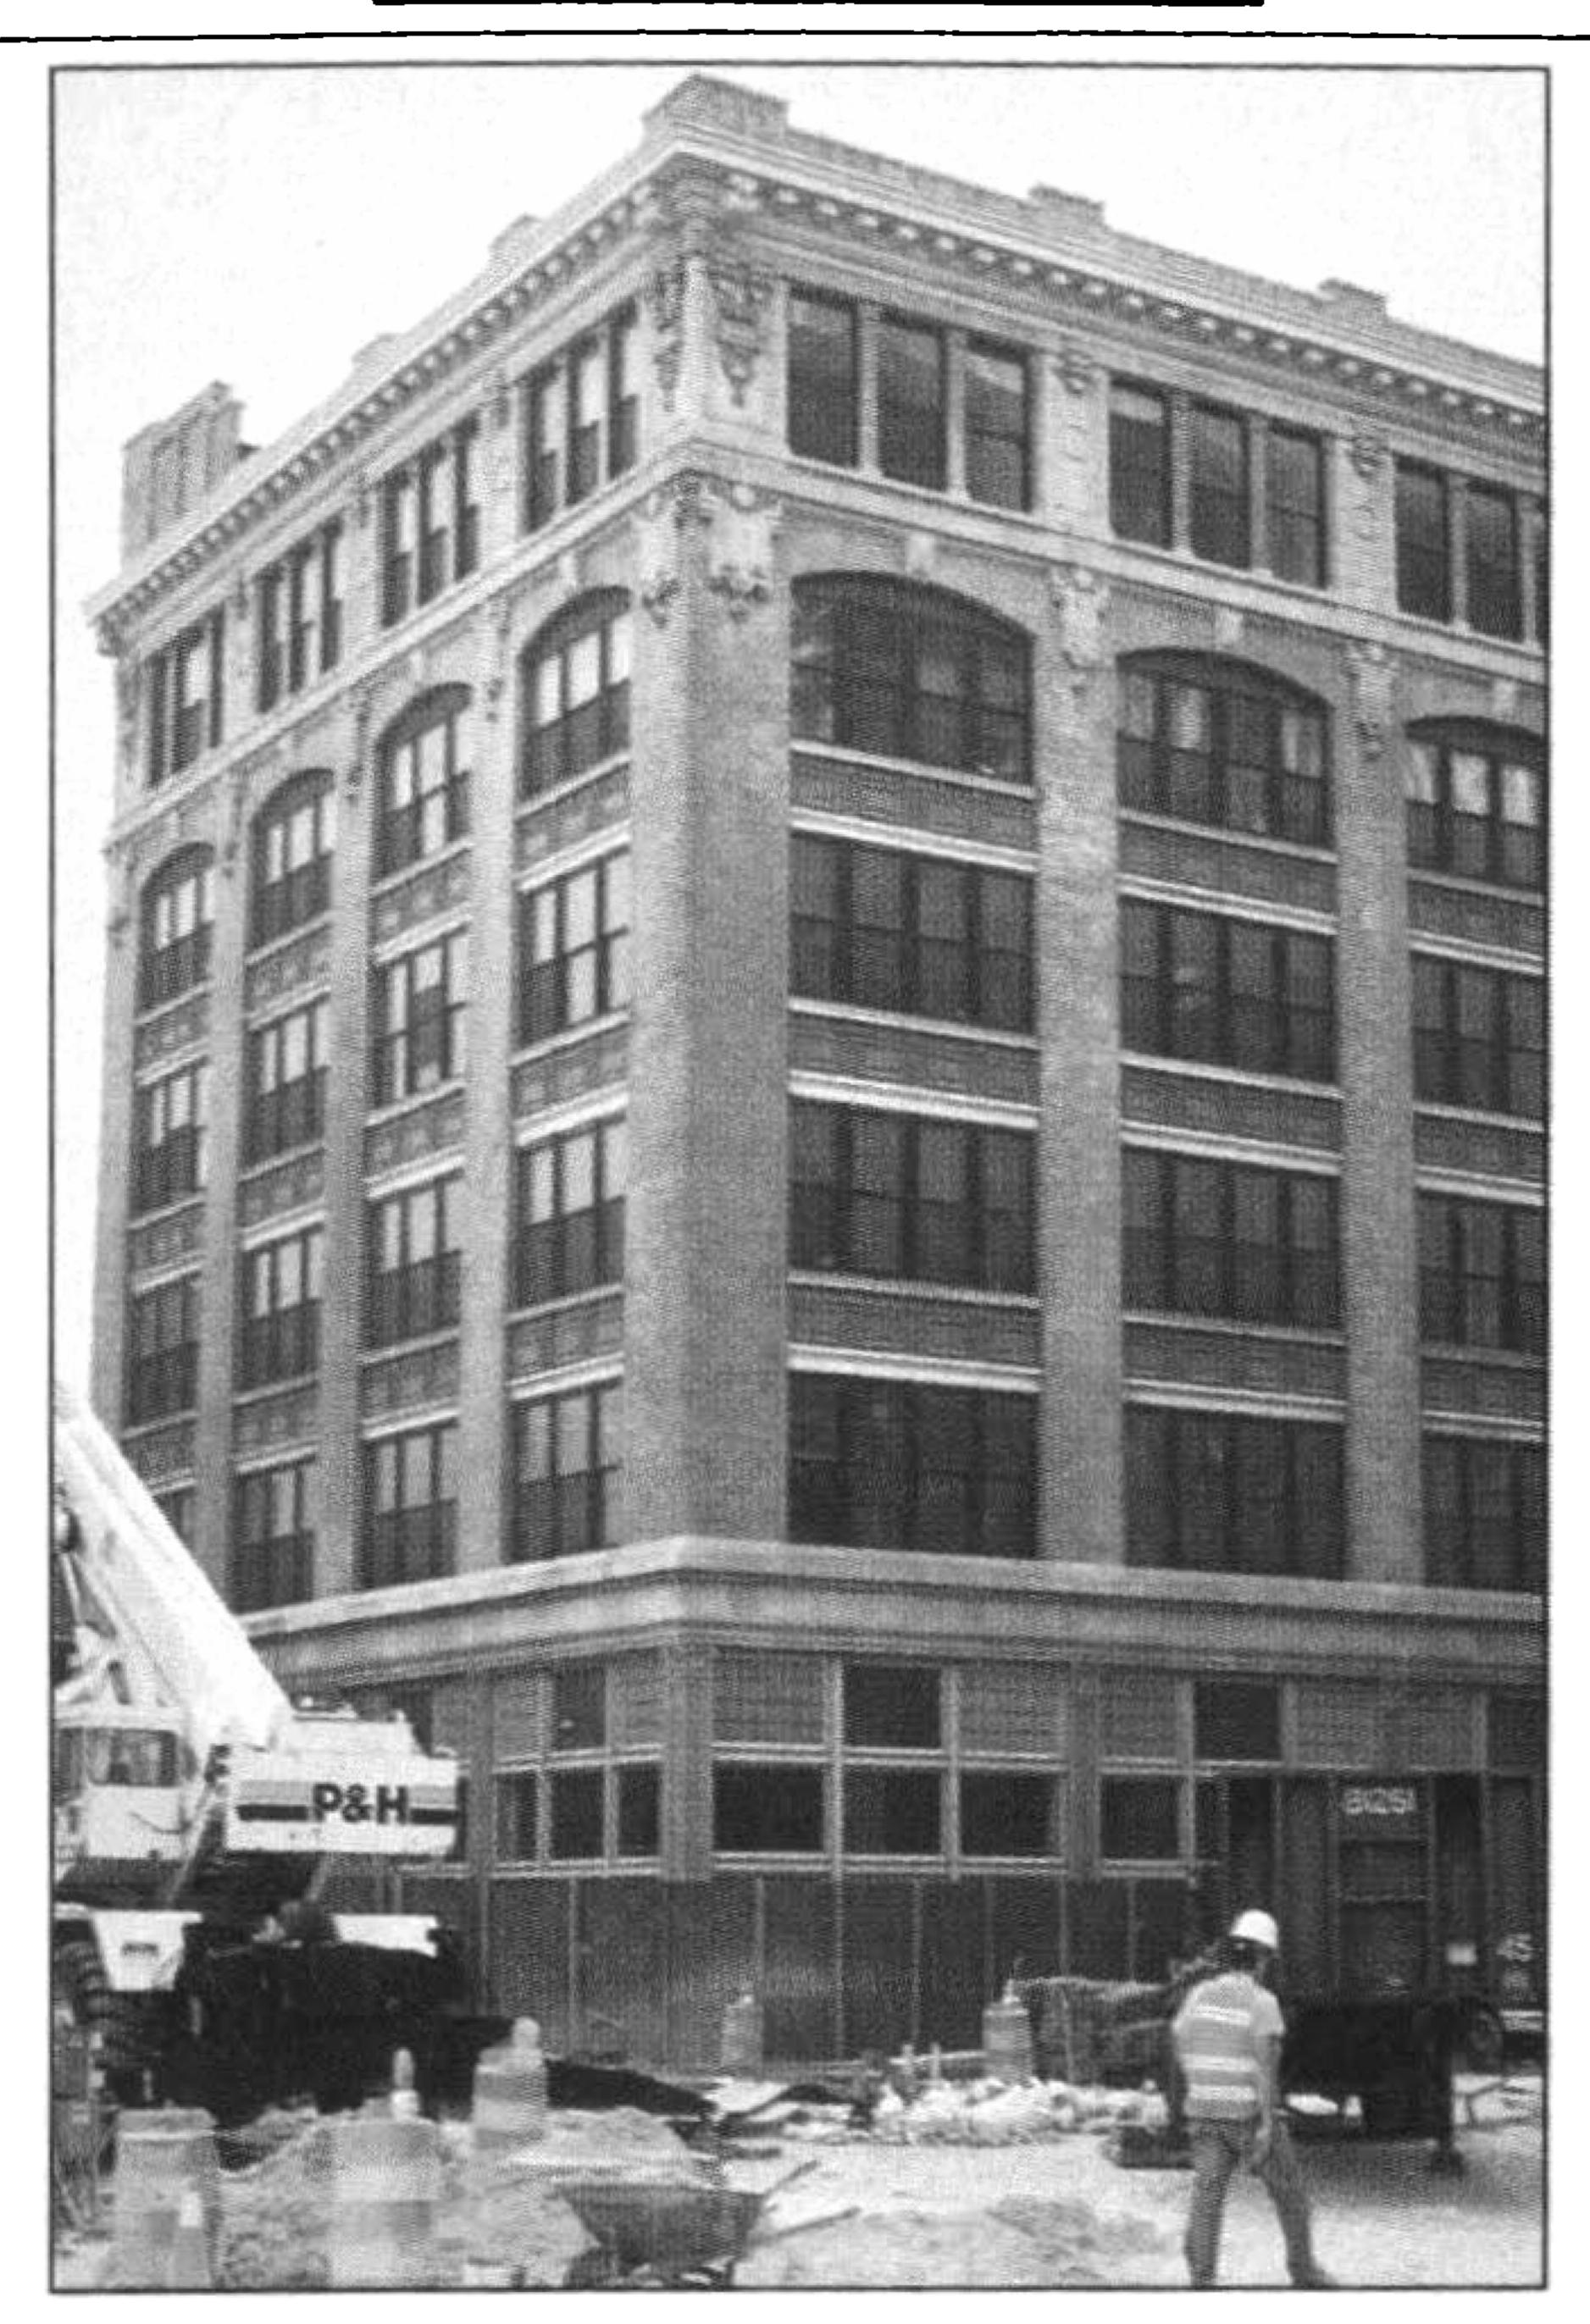
FUTURE TUNNEL CONSTRUCTION ENDANGERED THE FOUNDATION OF A CONCRETE BUILDING FROM 1910.

umns on six to eight piles. Soft rot and fungus had penetrated the interior piles, and worse problems were foreseen during the projected dewatering. The local ground elevation varies from El 7 to 10 ft, the final basement floor of the Bernstein Building is El 1, and the water table is at El 0.

After submitting the bid, NCI engineers reconsidered their strategy. Given the soft layer of soils, the deterioration of the existing timber piles and the time constraints of the project, they reasoned that a pin pile solution offered several benefits. It would limit the the excavation depths, the amount of undermining at at any one time and the total undermining time, while avoiding contact with the

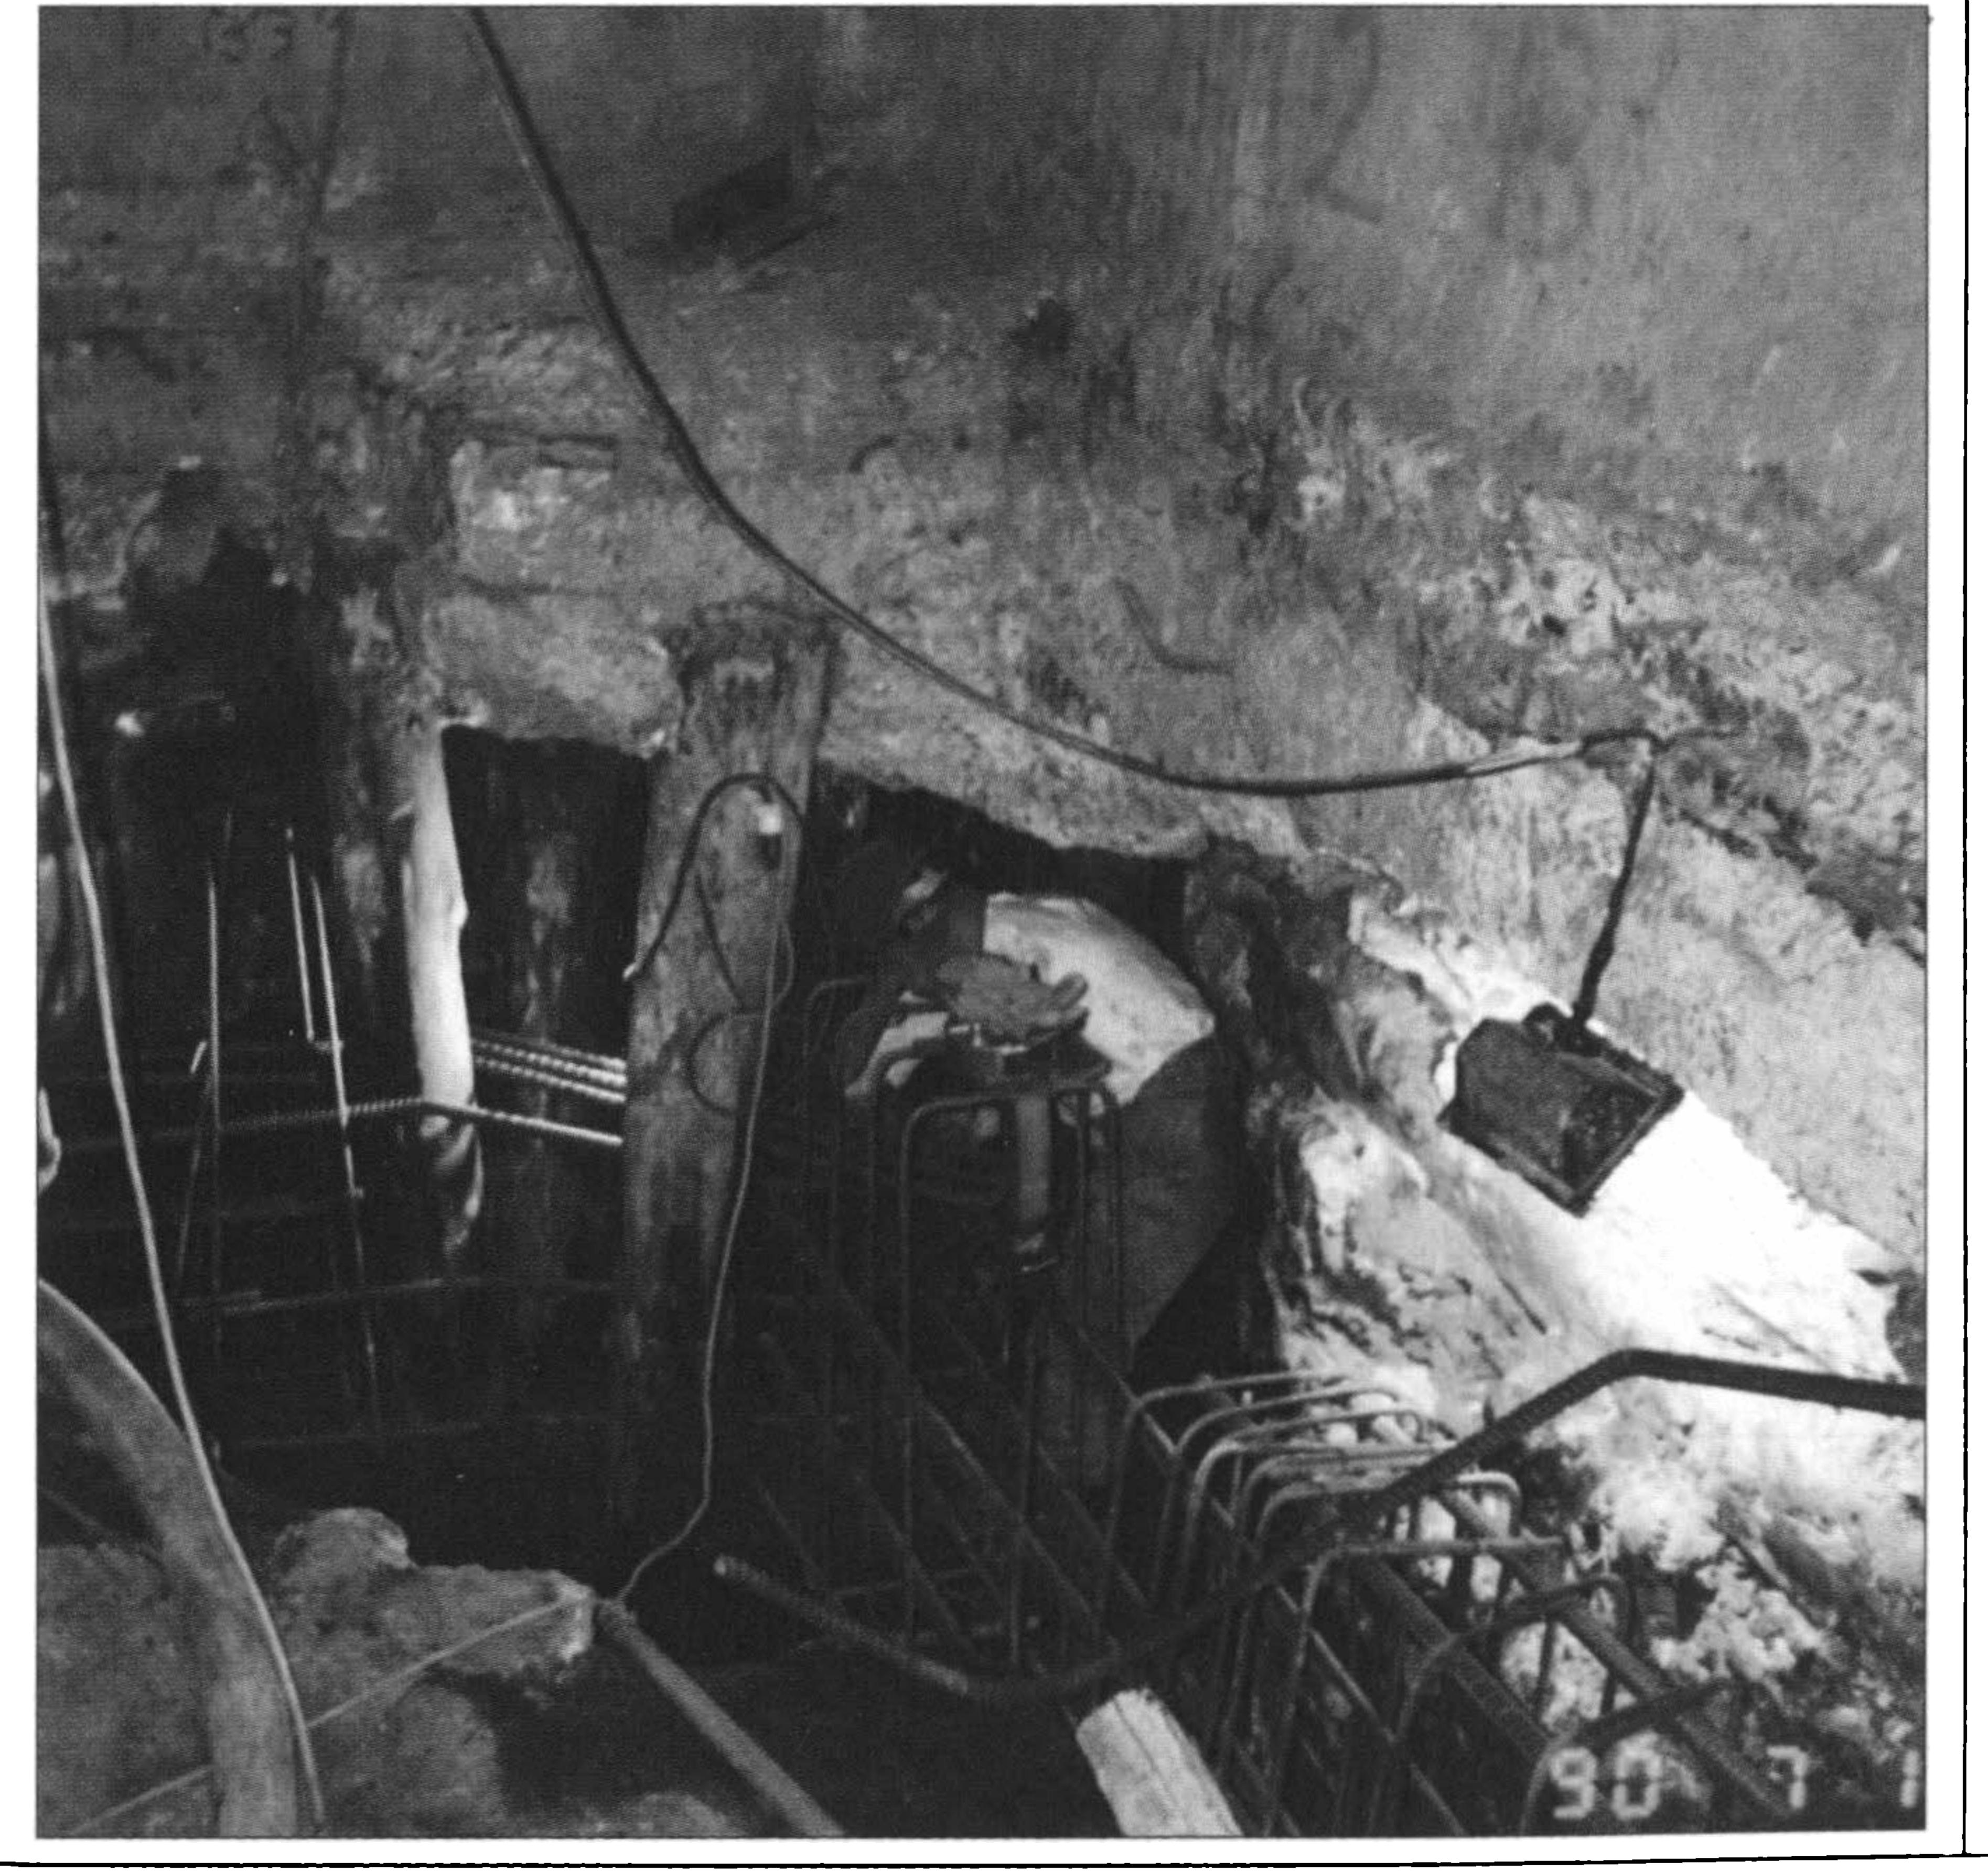
EXCAVATION STARTED WITH MACHINES, BUT, BEFORE WOOD PILES WERE REPLACED, THE AREA UNDER THE OLD CAP HAD TO BE DUG BY HAND TO PLACE REBAR FOR THE NEW CAP AND BEAM.

During the four or five days required for the grout to reach its target strength of 4,000 psi, the new caps were completed so that the building load could be transferred to the pin pile. First, the soil beneath the existing timber pile cap or load-bearing wall had to be removed by hand. The space available to the workman often determined the depth of the new cap. As he scraped away loose surface material, the engineers had to make final design modifications and submit them for review and approval.

This step proved critical because at this point the structure above was supported only by the exposed timber piling, which in turn obstructed rebar and concrete placement for the cap that completed the load transfer. Because the timber pile sizes and planned location varied, the rebar had to be shifted and bent horizontally and vertically. Each placement was a custom job and inspec-

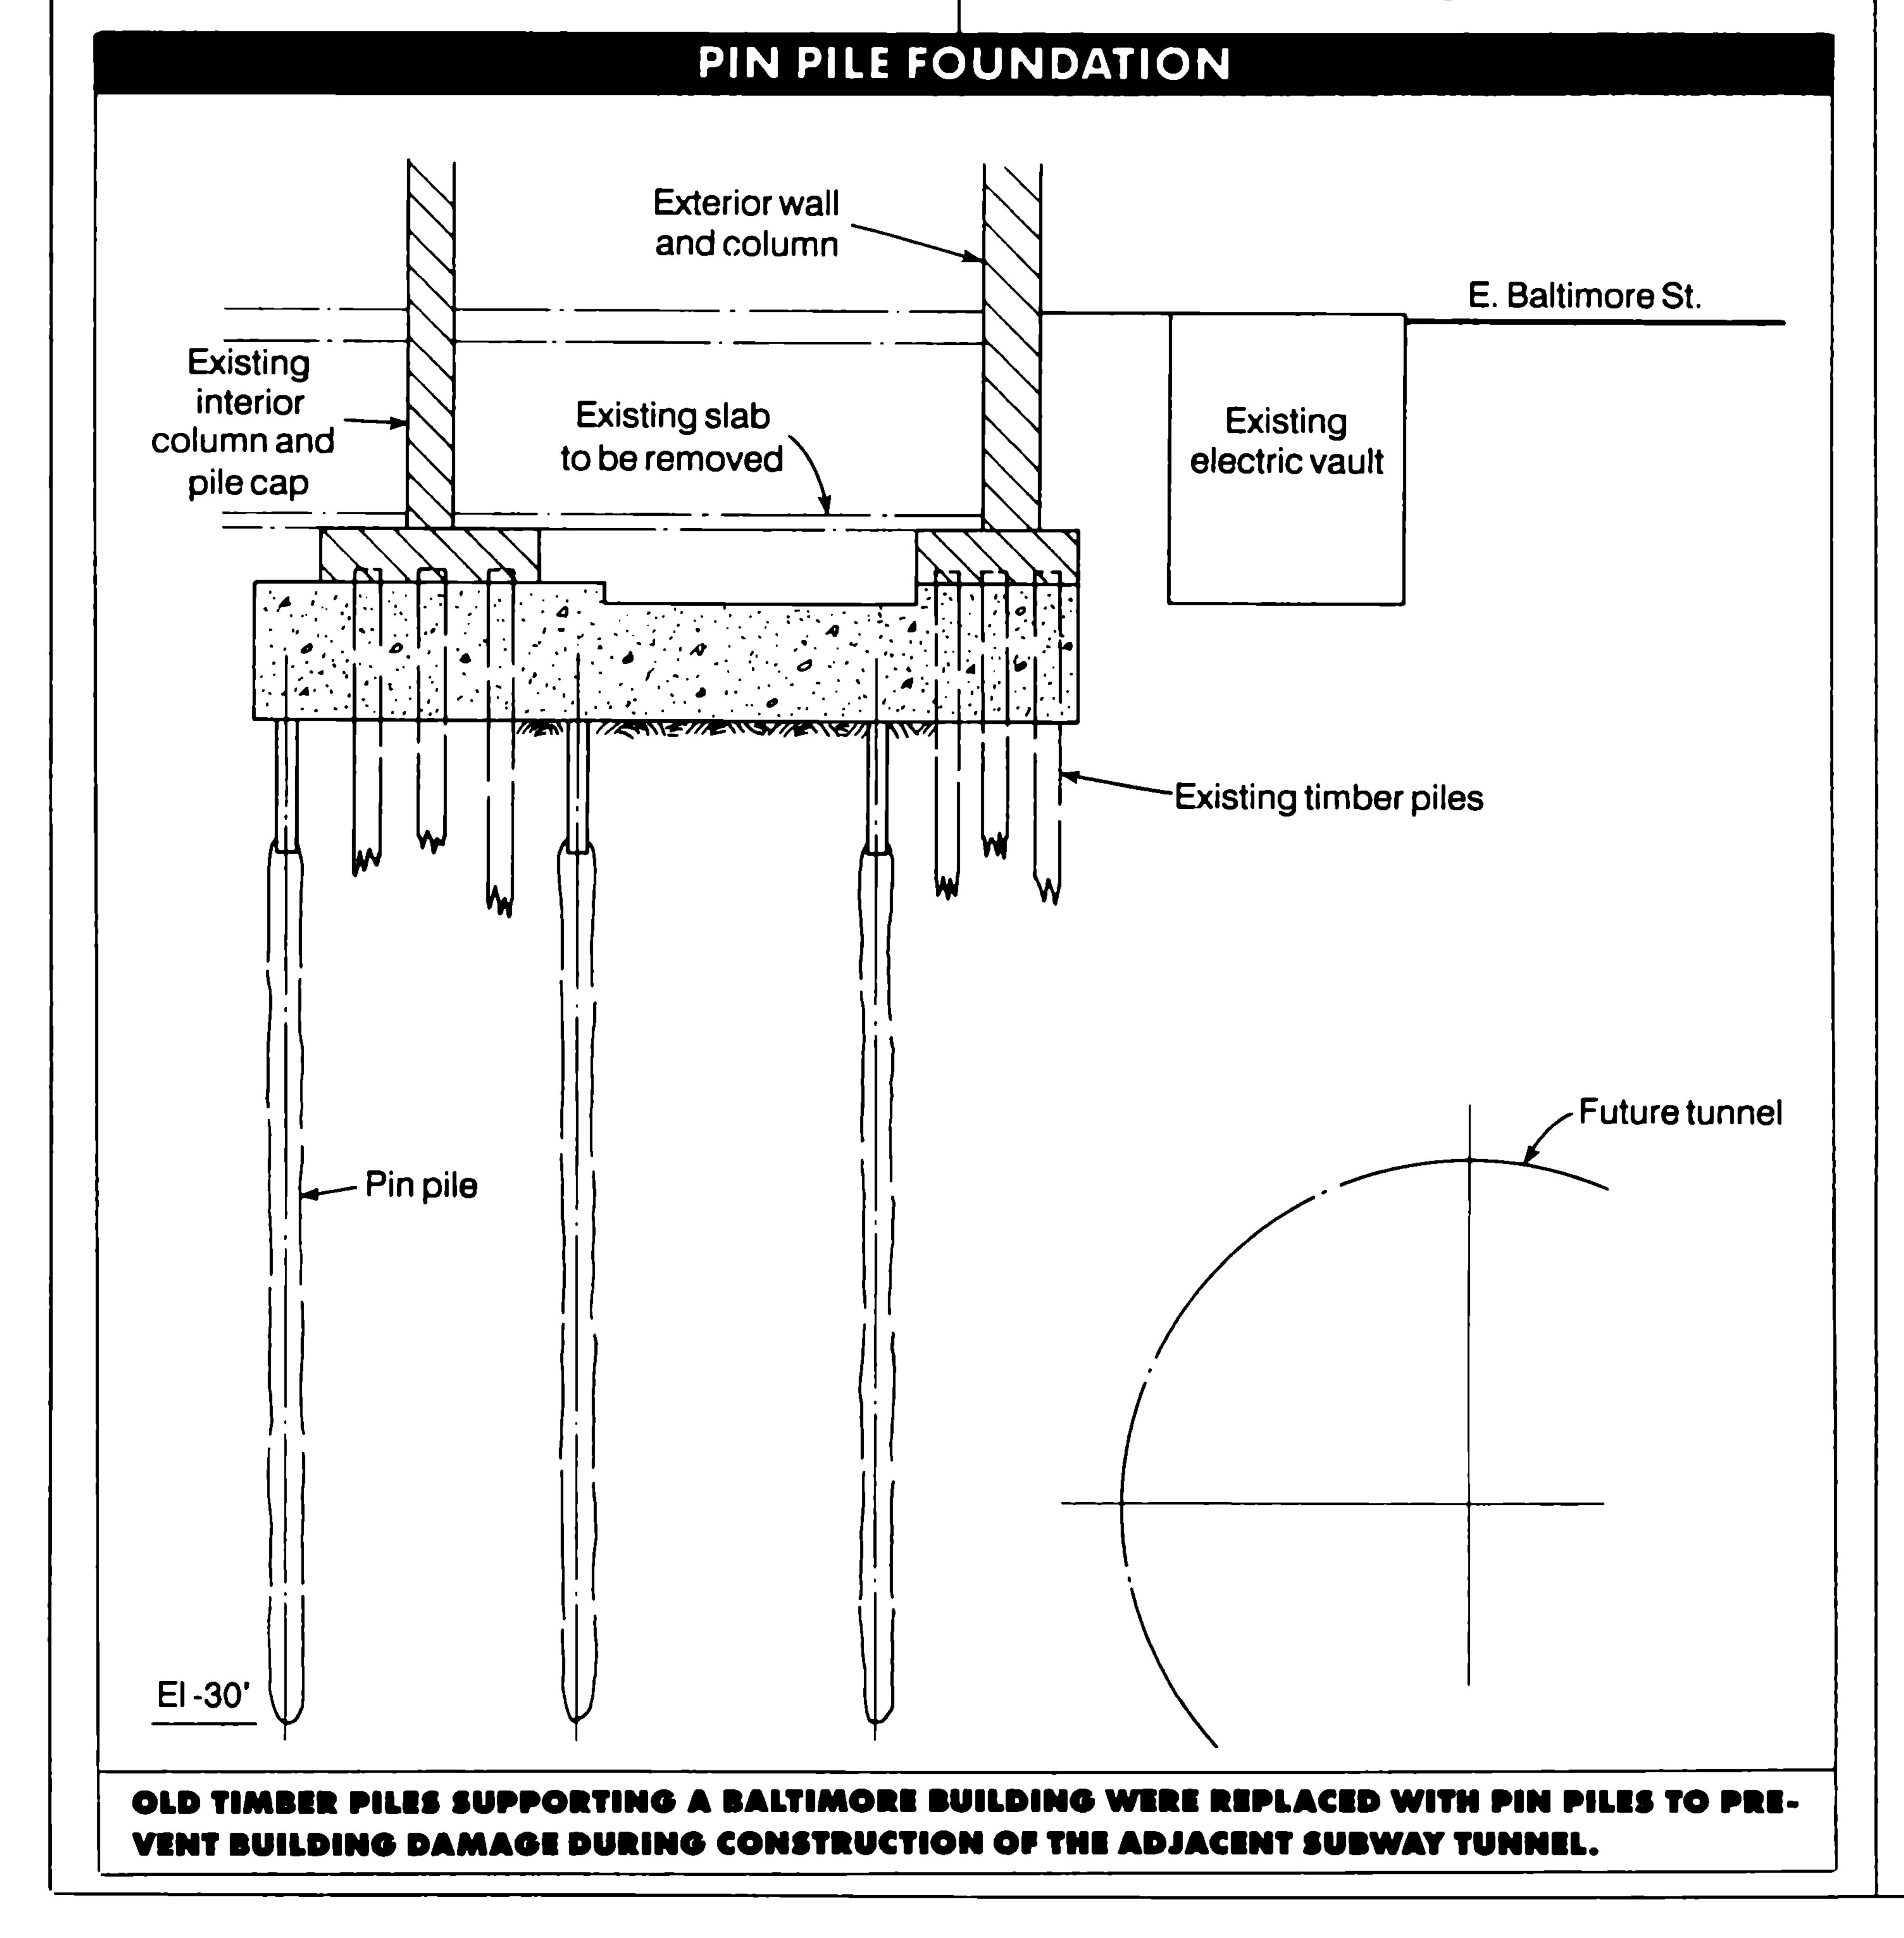
Replacing old wood piles with pin piles would limit the undermining required at any one time to stabilize the masonry building.
